1) Checking selective passive currents

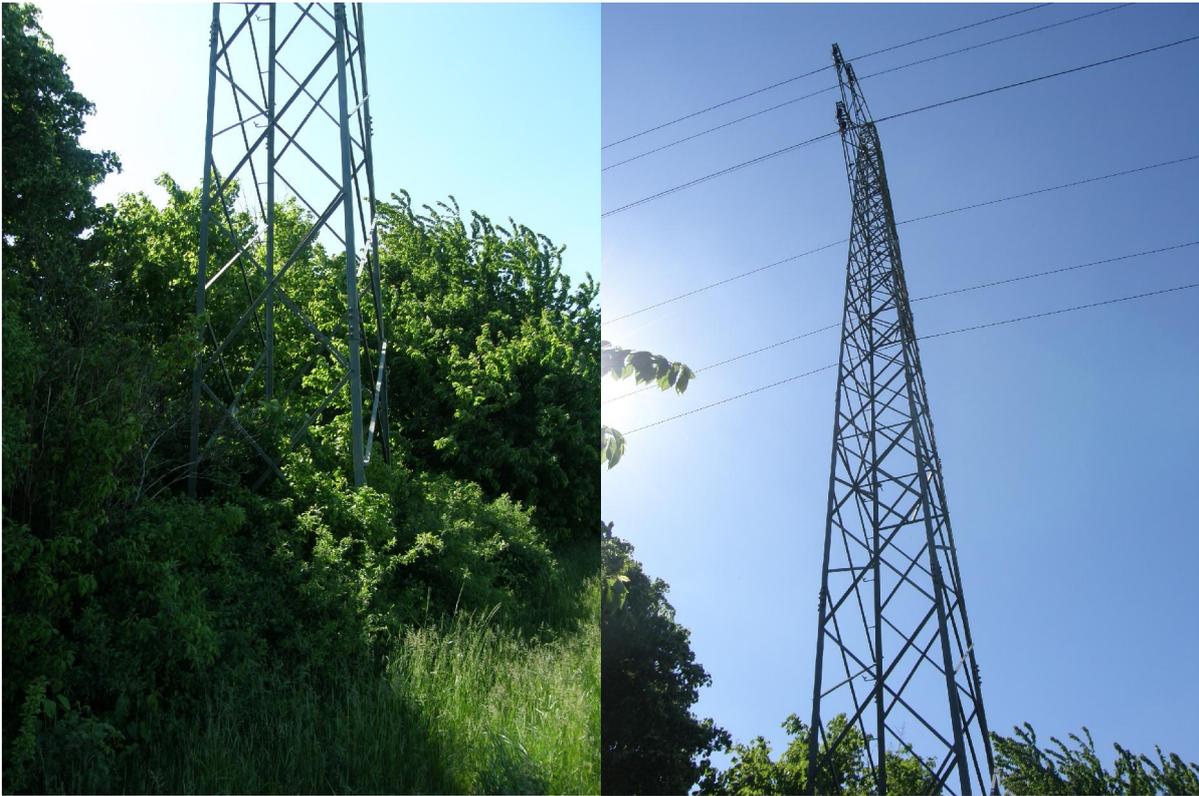
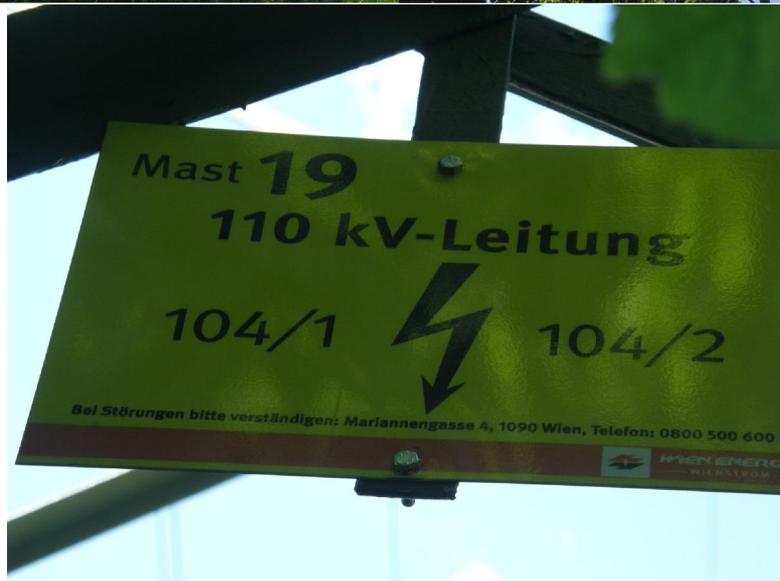
Selective passive current measurements of pylon legs with Ampflex gave (noise frequency was 50Hz):

- I1 = 630mA
- I2 = 500mA
- I3 = 630mA
- I4 = 666mA
- Overall current: 200mA

The single currents don't cancel each other completely; this means that current is also flowing into the **earth rope at the pylon top**, which therefore **must be connected**.

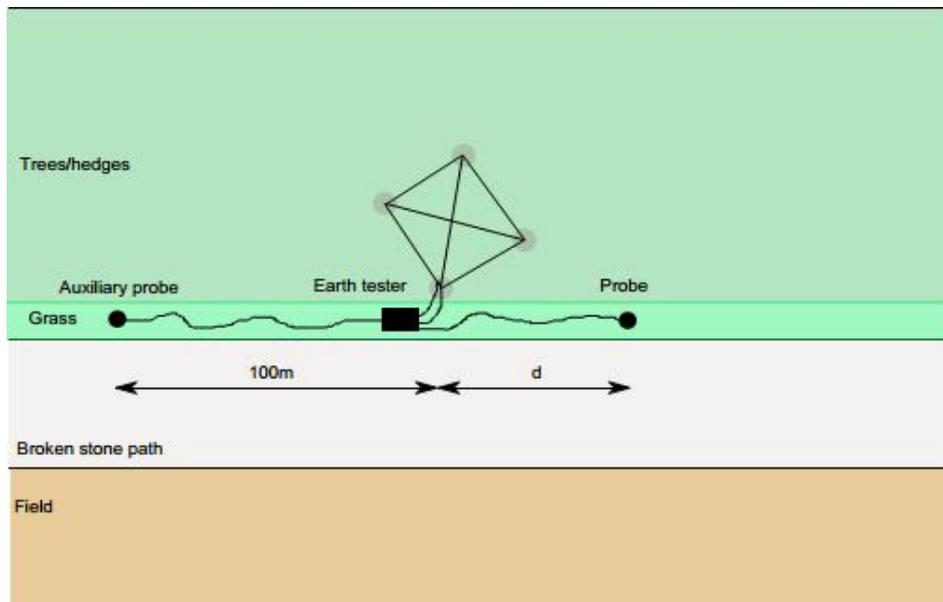
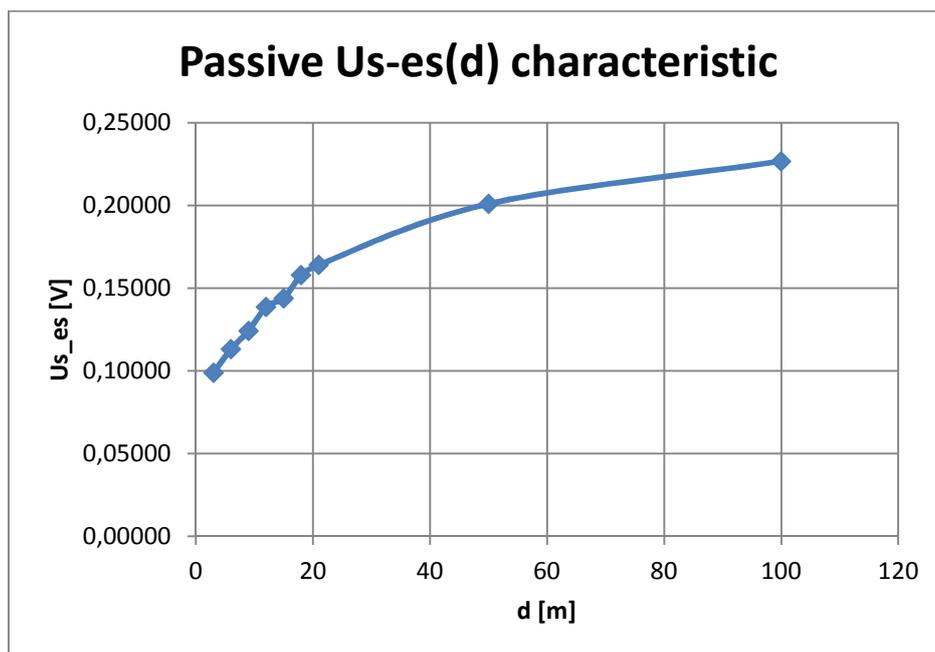
Configuration see picture; for the auxiliary probe 3 rods in parallel where used, where for the probe only 1 rod was driven into ground.

U_{h-e} remained quite constant when relocating the probe, U_{s-es} rose with distance from pylon (Obj. 1/Tst. 2+5-12). This could mean that there was less ground resistance north of the pylon (maybe due to buried tubes or cables?) and that the **potential funnel of the pylon for the 50Hz noise currents reached even beyond 100m south of the pylon**. The low U_{s-es} value in Obj01/Tst13 was probably a measurement error (compare with Obj01/Tst21+22)...

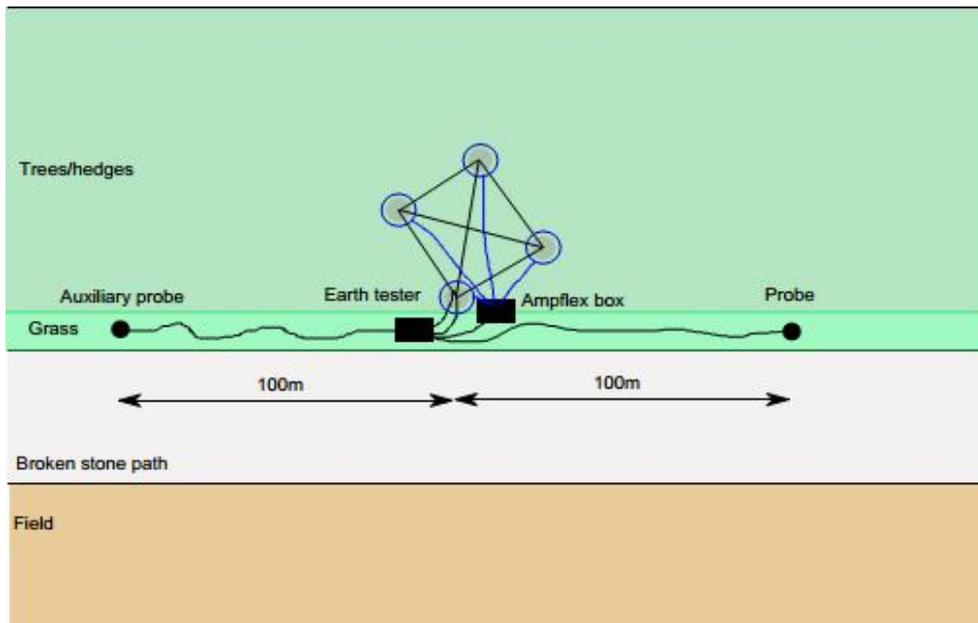
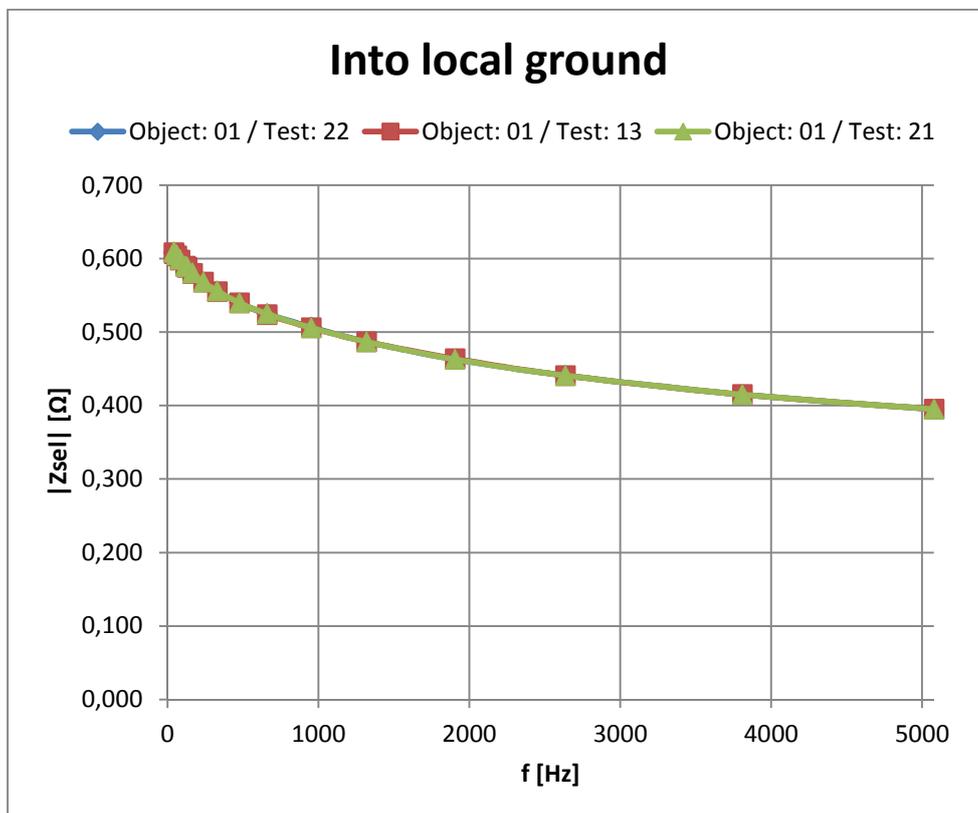
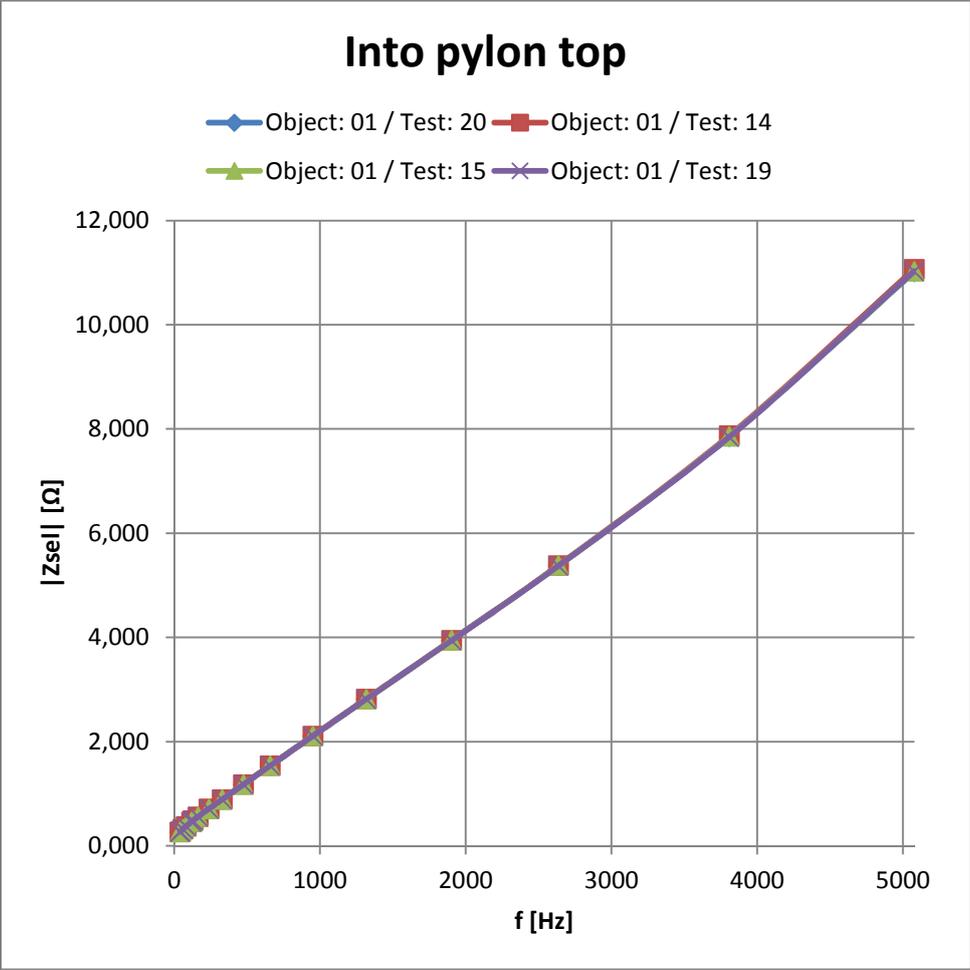
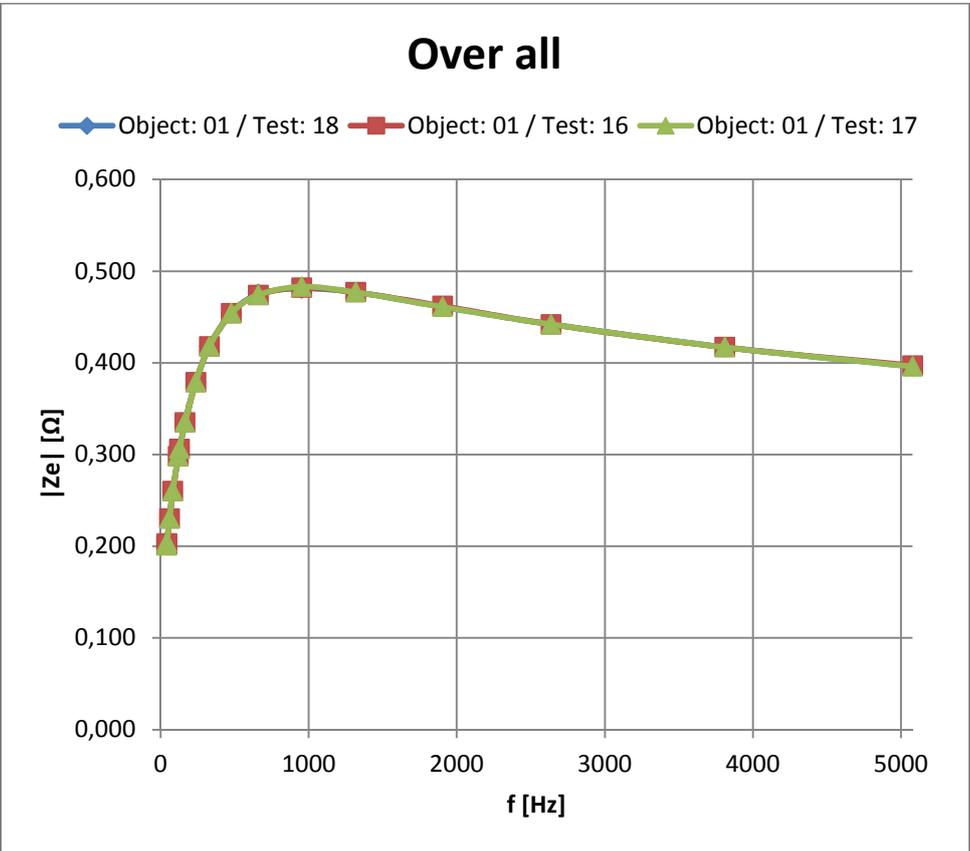
Configuration see picture; for the auxiliary probe 3 rods in parallel where used, where for the probe only 1 rod was driven into ground.

The selective measurements into pylon top and ground are all reproducible and show smooth curves, speaking of the quality of the measurement. The curves into the top earth rope are almost linear, showing very nice the inductance of the earth rope. **Local earth resistance is approximately 0.4 Ohms**, which is quite good.

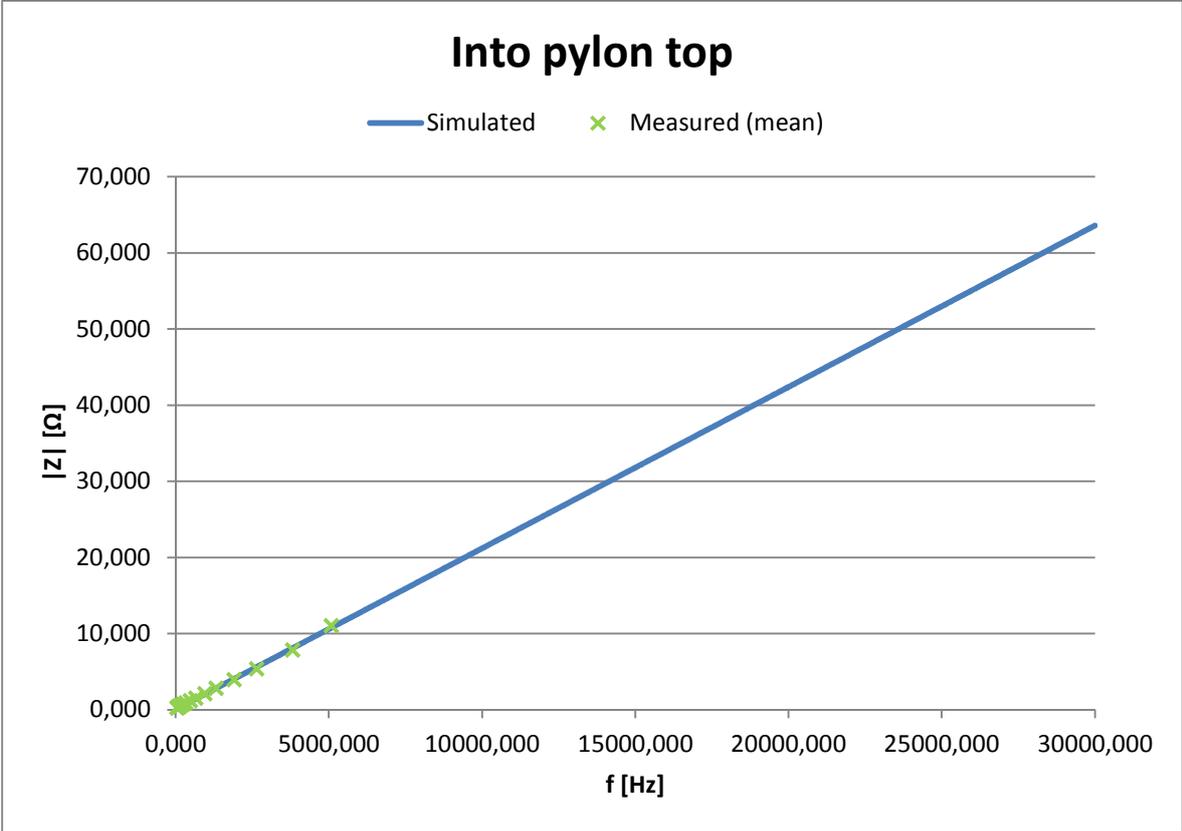
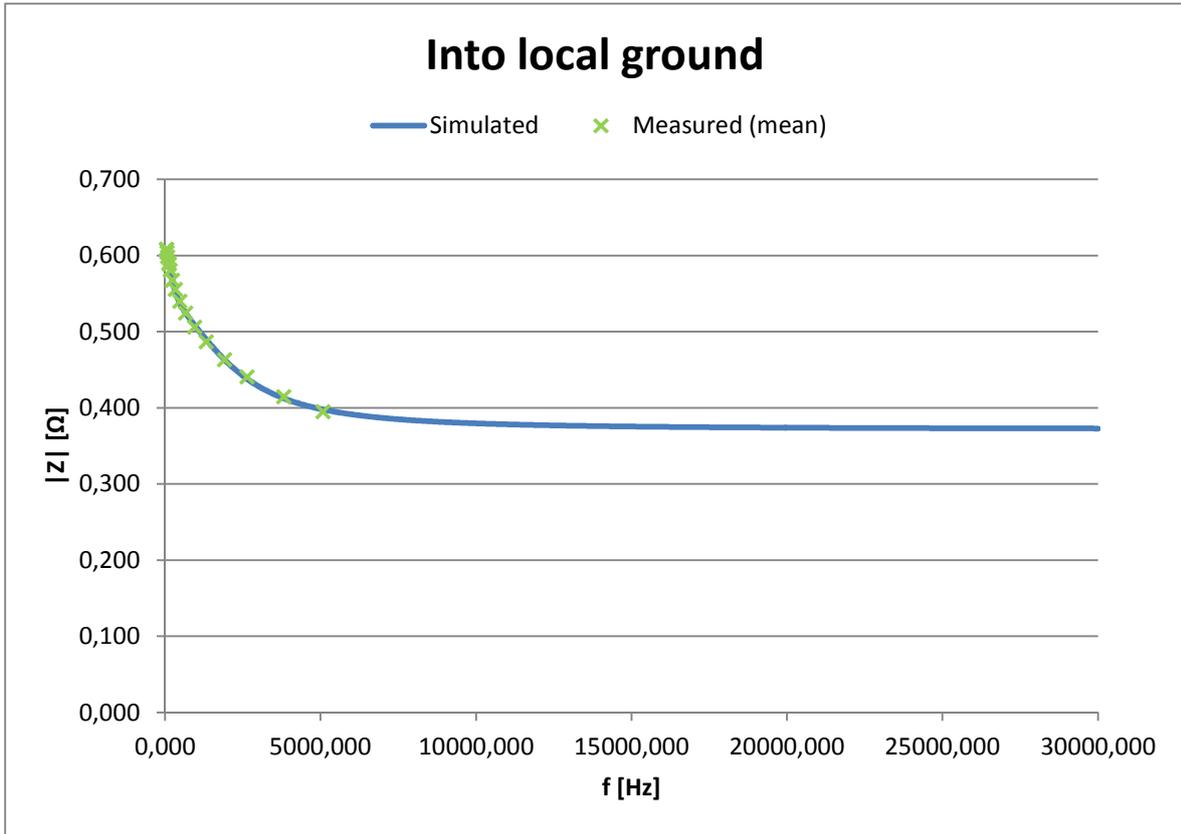
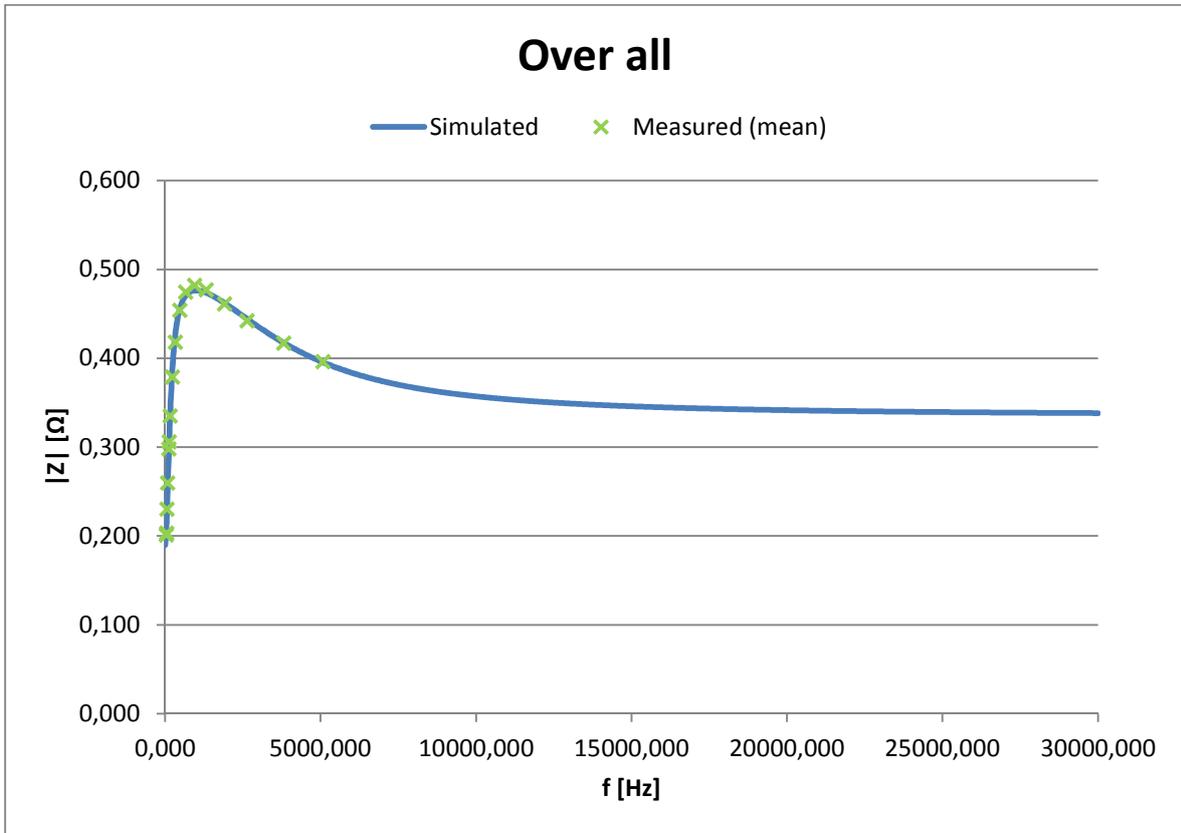
The simulated curves **fit the measured values very well** and **seem thus to be quite reliable**.

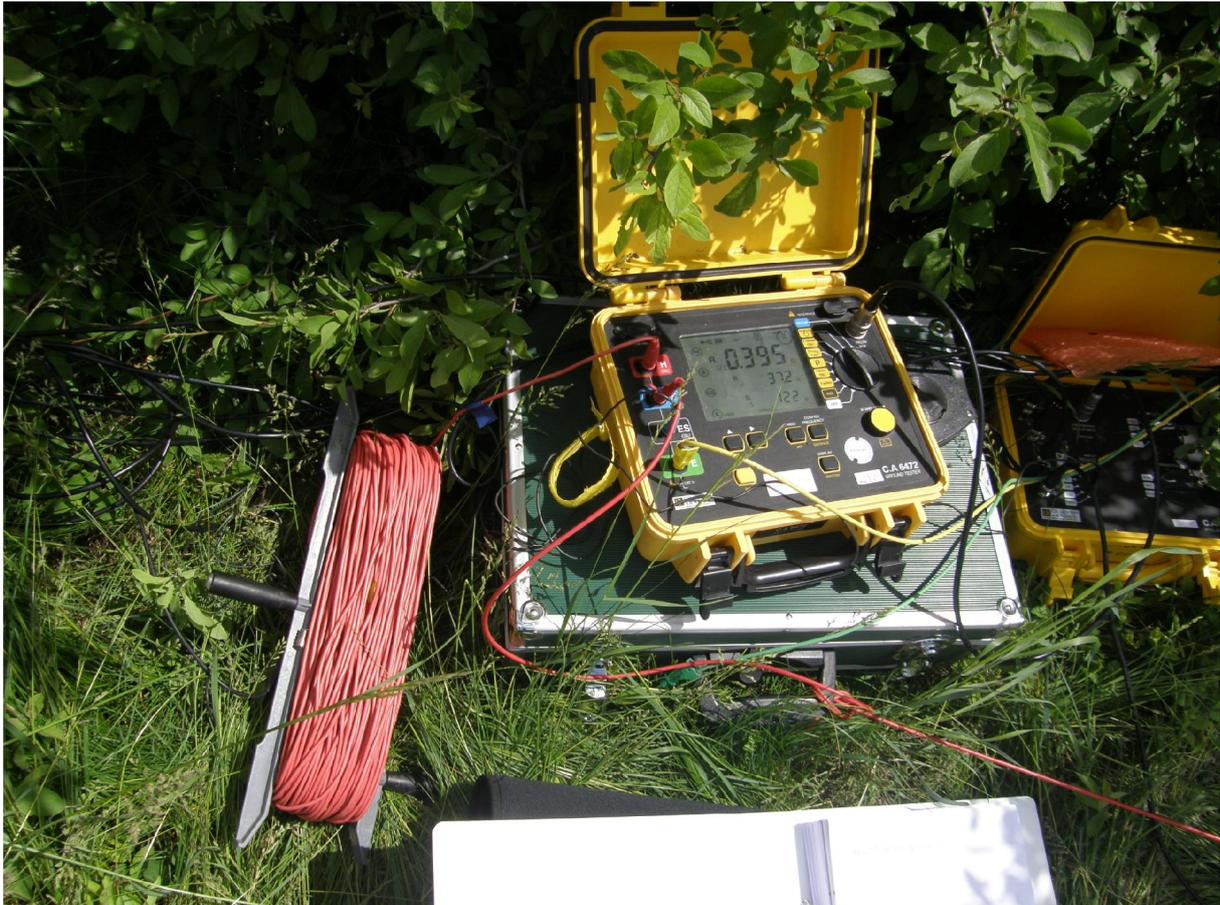
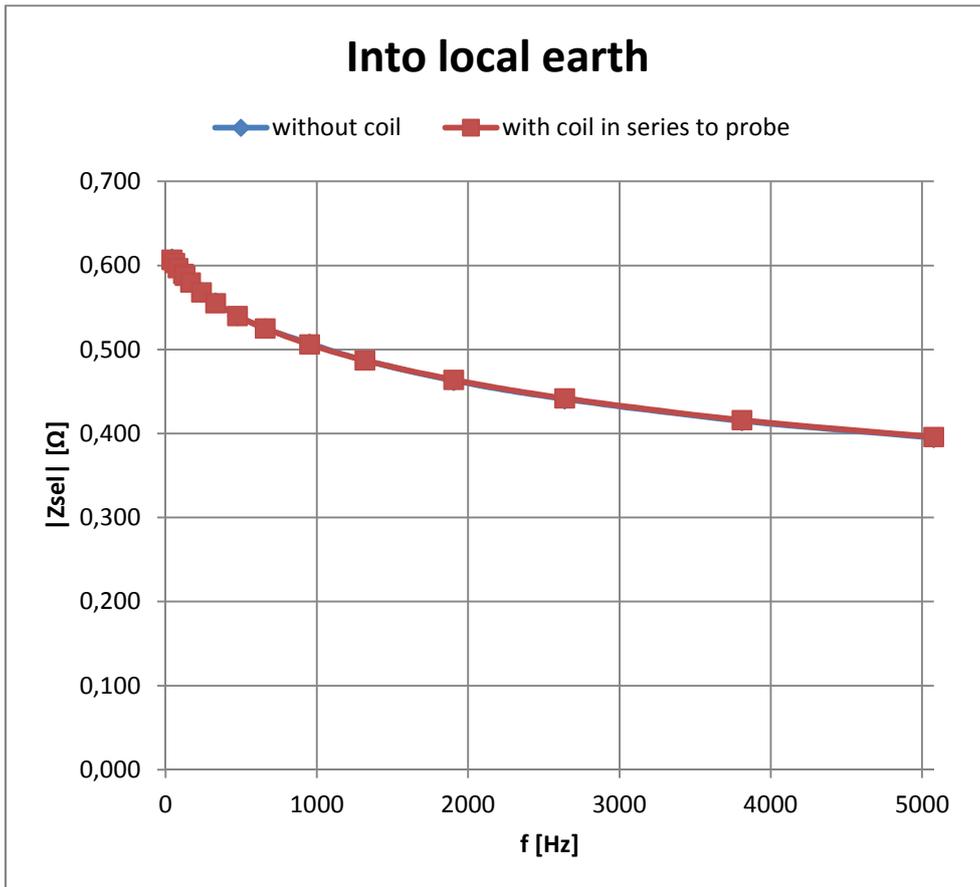
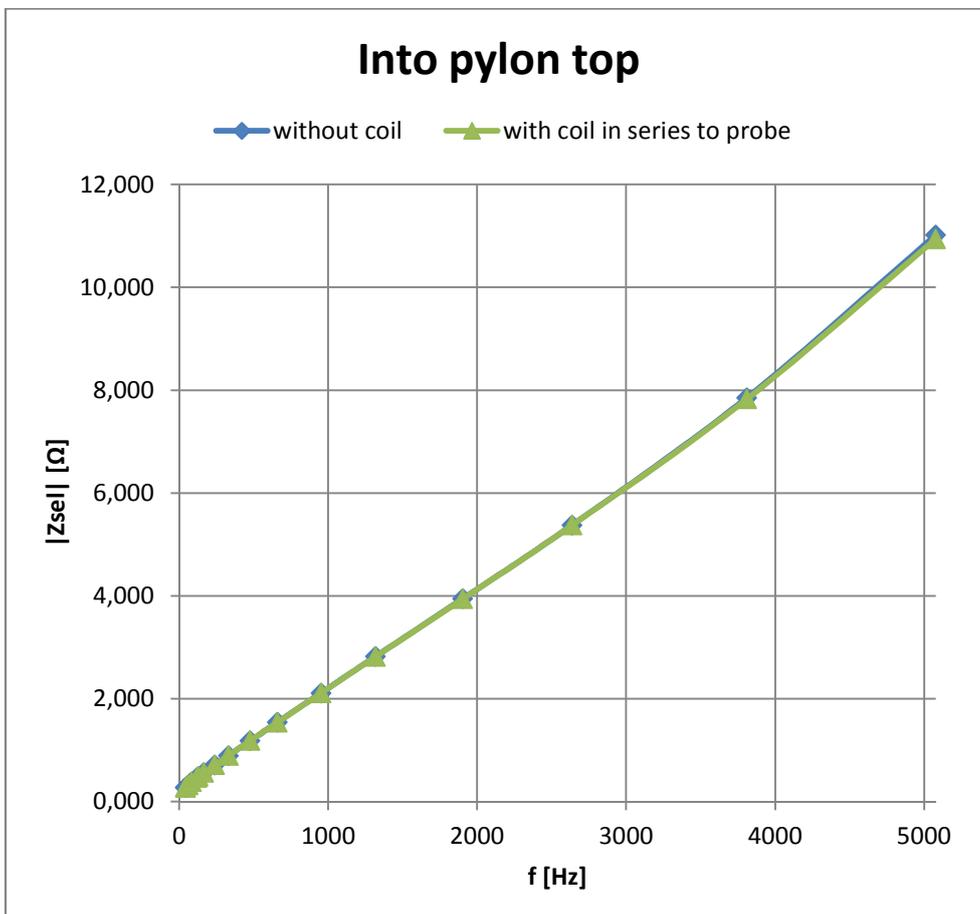
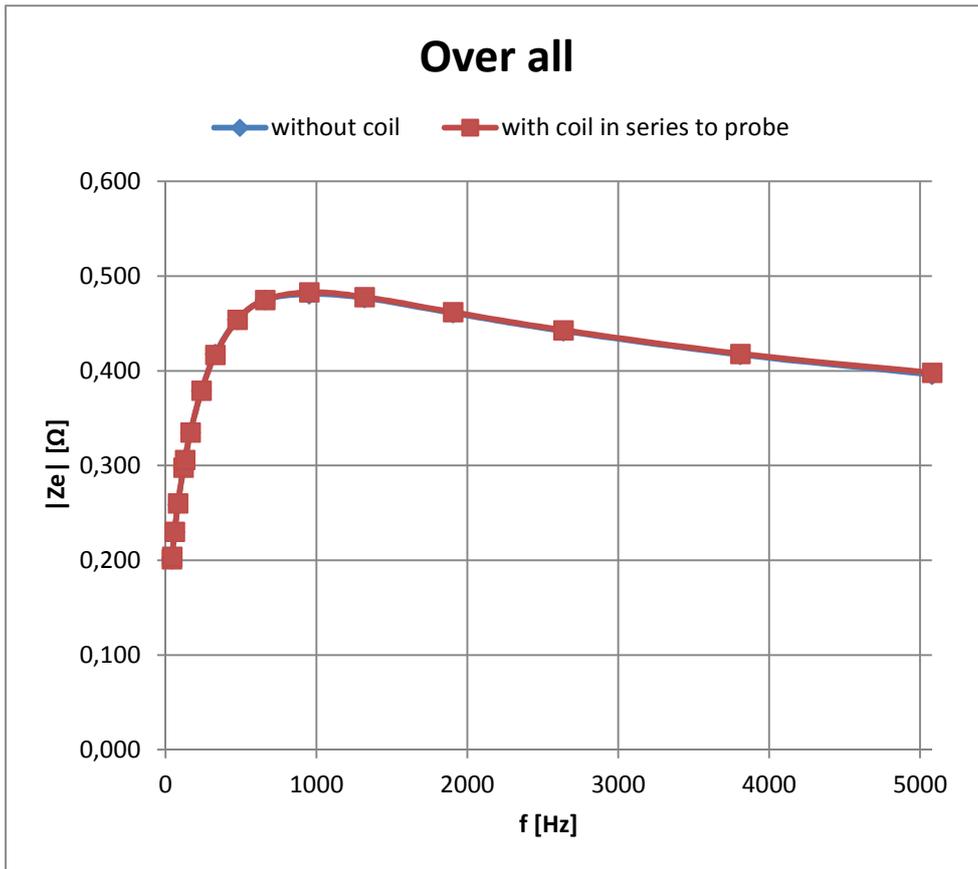
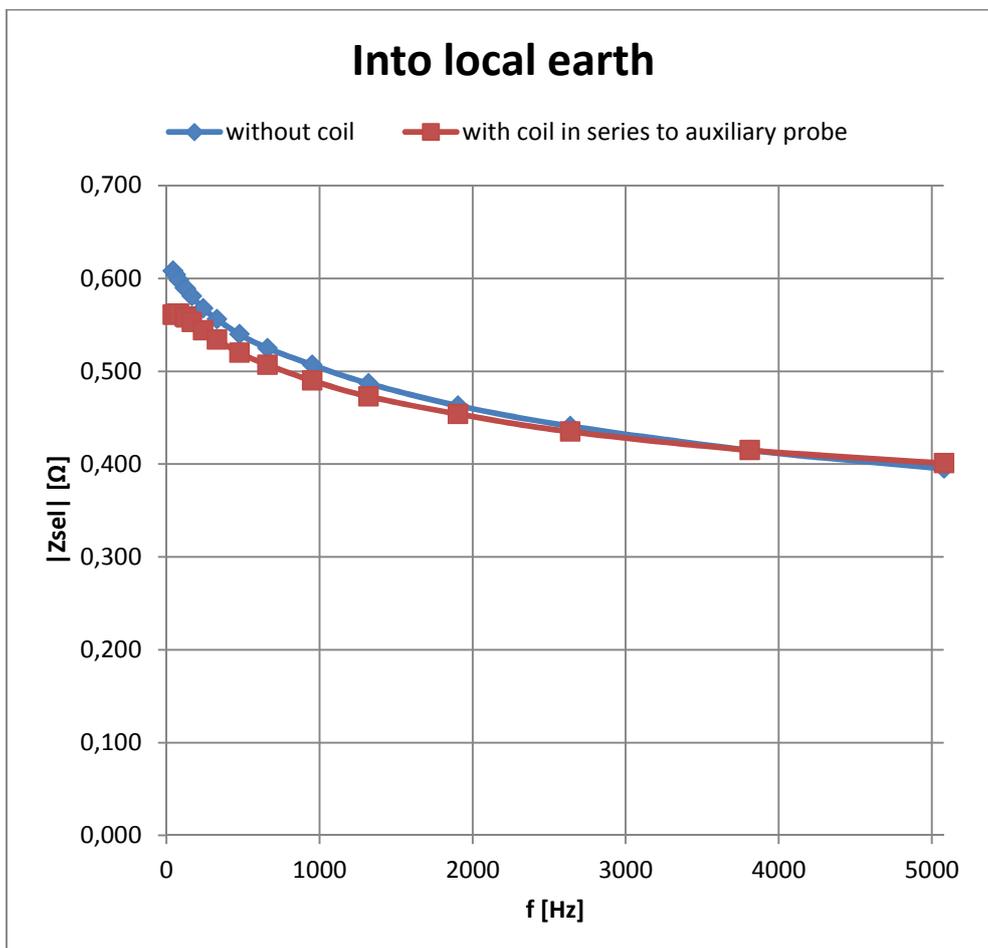
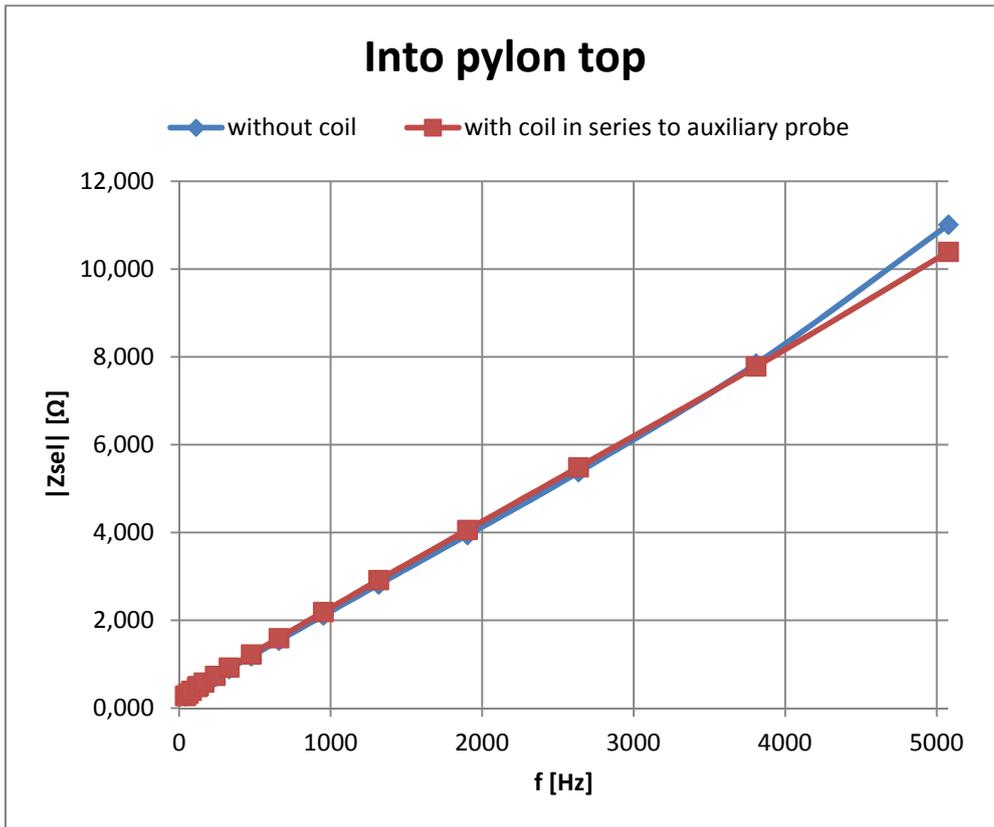
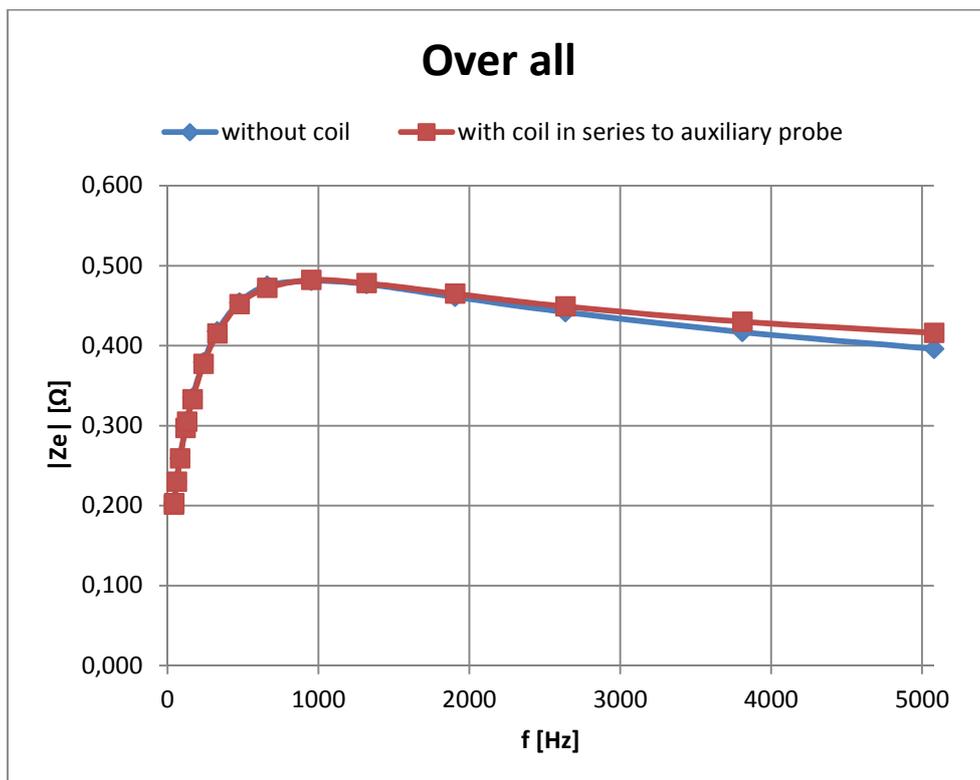
Connecting a **100m wire coil uncoiled in series to probe/auxiliary probe** resulted in **no differences with Ampflex/4 Pole Measurement at the probe**, but produced **slightly too small results at the auxiliary probe** (Ampflex results too small, thus 4 Pole over all too high; results for included coil in red, without coil in blue). Explanation: Current between S and ES is very small, so the additional inductivity in the probe connection doesn't influence the result. The cable coil inserted into the auxiliary probe connection on the other hand alters the results. The reason for this lies in the fact that driving a rectangular voltage into the coil causes spikes leading to sampling problems in the measurement process.

⇒ Therefore one must take care to always fully uncoil the cable coil for the auxiliary probe connection!

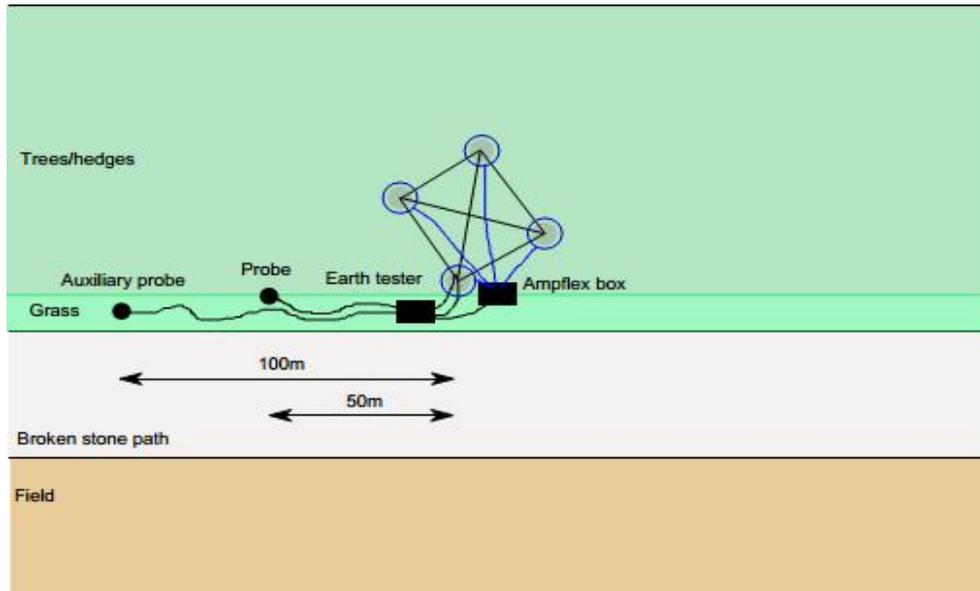
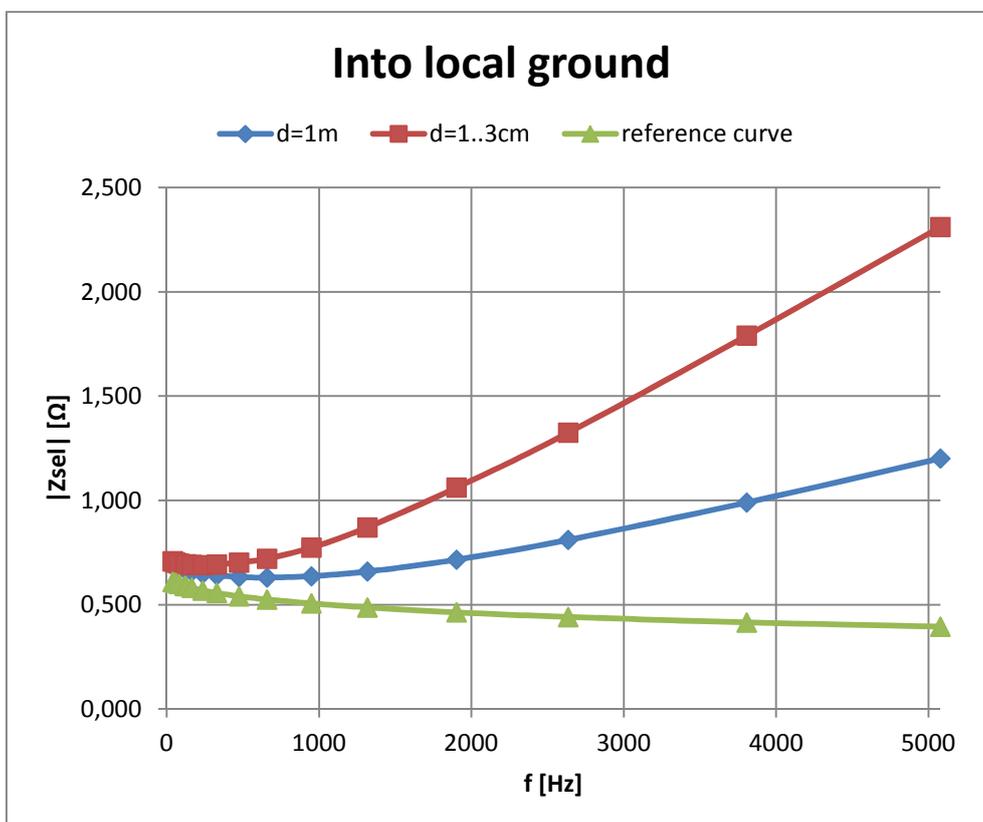
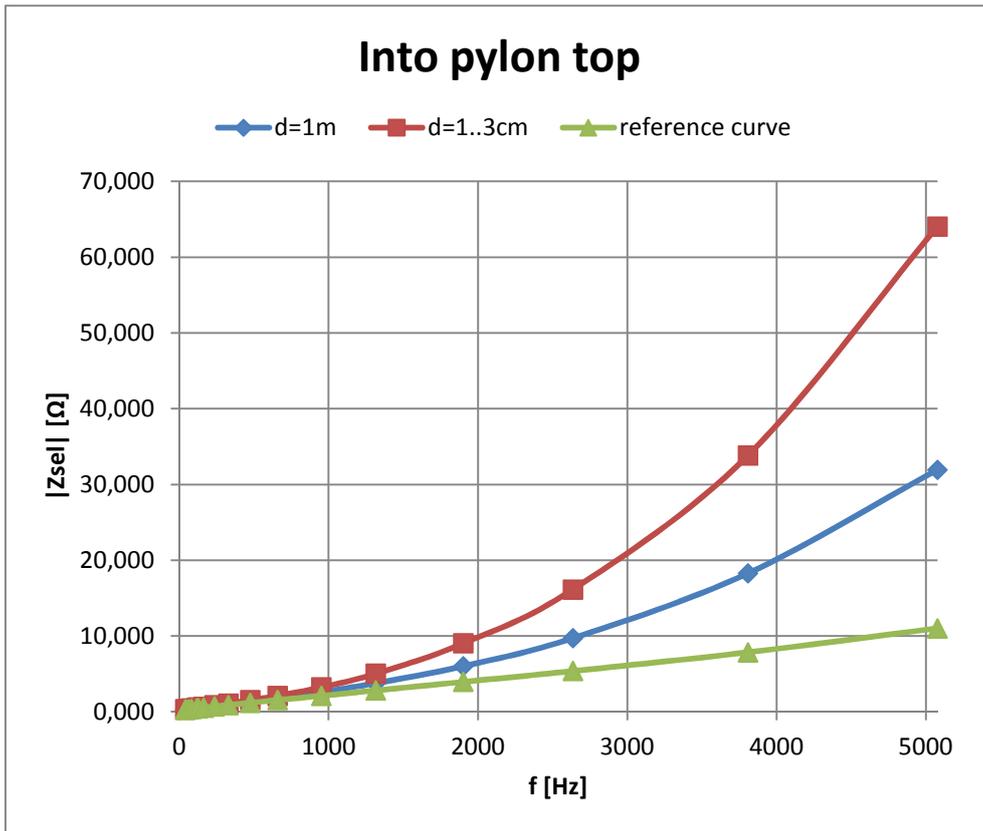
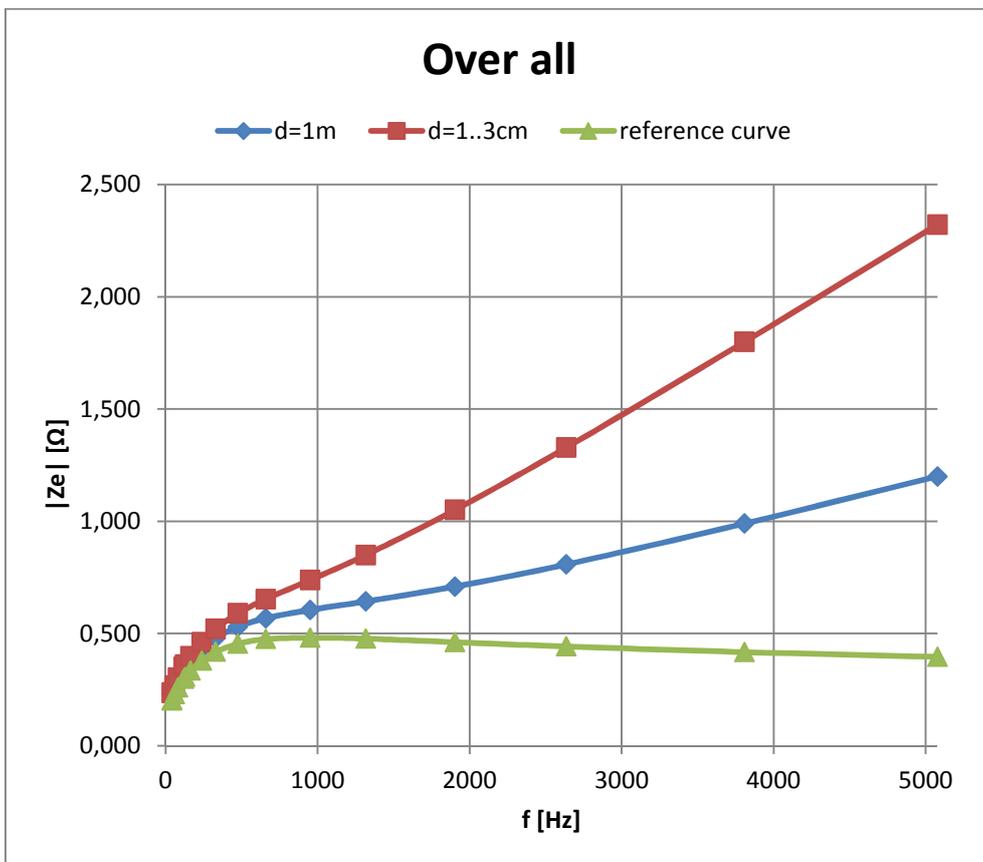
Guiding the probe cables in parallel (despite of making a measurement mistake due to the probe residing not exactly on the 62% point between auxiliary probe and local earth) shows clearly **capacitive effects leading to significantly higher earth resistances**, especially for higher frequencies. The effects are (as expected) stronger if the distance of the cables is smaller.

The diagrams show the reference curves (probe and auxiliary probe laid out in opposite directions) in green, the results for 1m distance between the parallel probe/auxiliary probe cables in blue and the ones for a distance of 1-3cm in red.

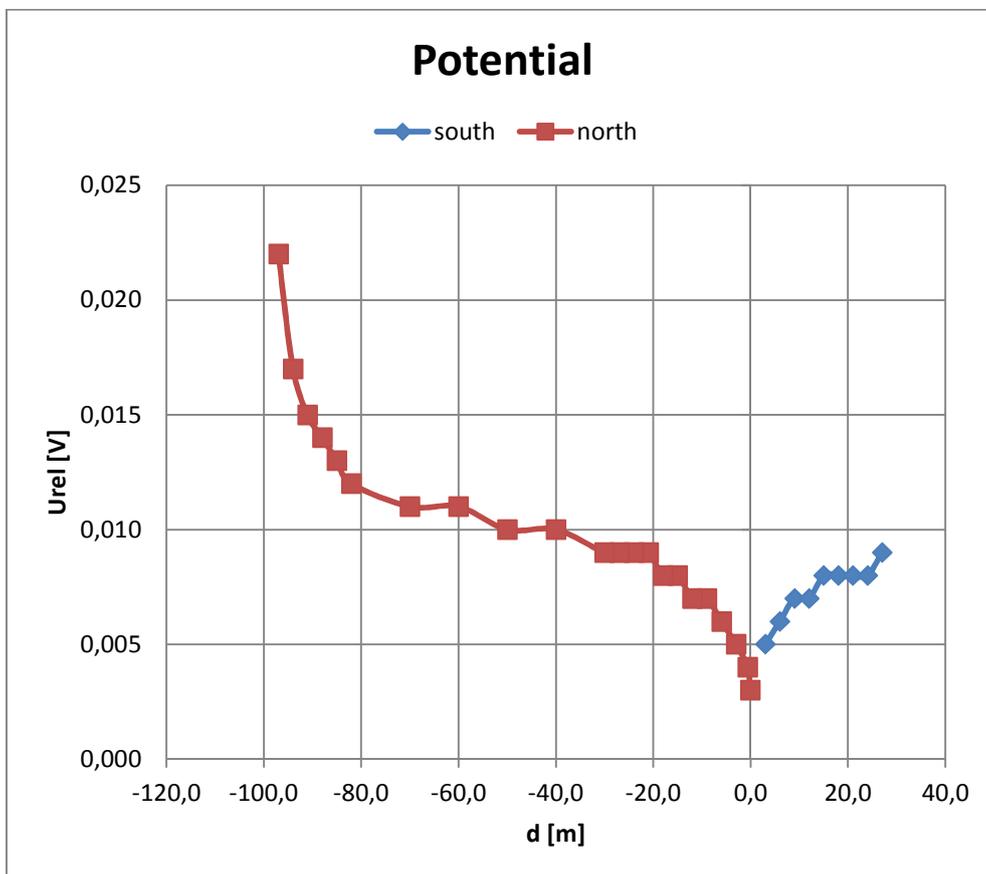
The **potential curves** (Obj. 3+4) show the **expected shape**. The smoothness of the curve is limited by the resolution of the measurement and the high ground conductivity leading to small potential differences.
